Post-Assessment Report

Community: [Santa Clara](#)

Project: [Santa Clara Project](#)

[June 26, 2015](#)

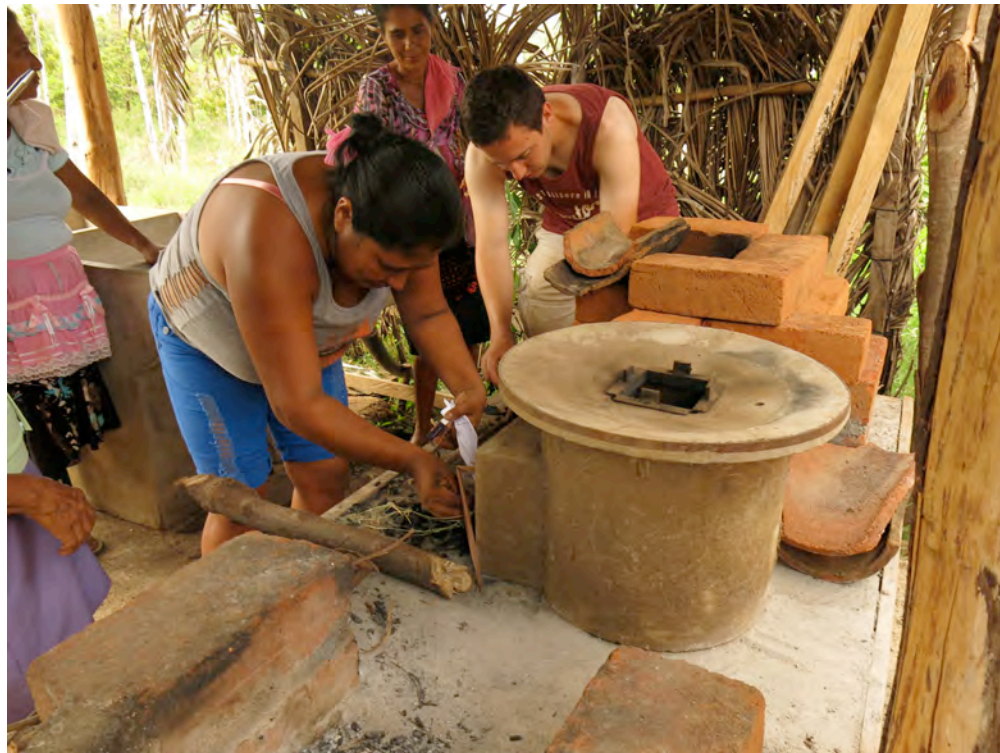
Two improved stove options being tested.

- Visible smoke production was reduced, and the visible ash content of the smoke that was produced was lower.
- The stove easily accommodates use of the *comal* in addition to pots or pans.
- The stove opening is large enough that big pieces of wood can be inserted, making the feeding process less onerous.
- The stove is a good height for cooks, and less heat escapes through the outside; this keeps the sides of the stove cool and prevents children from burning themselves

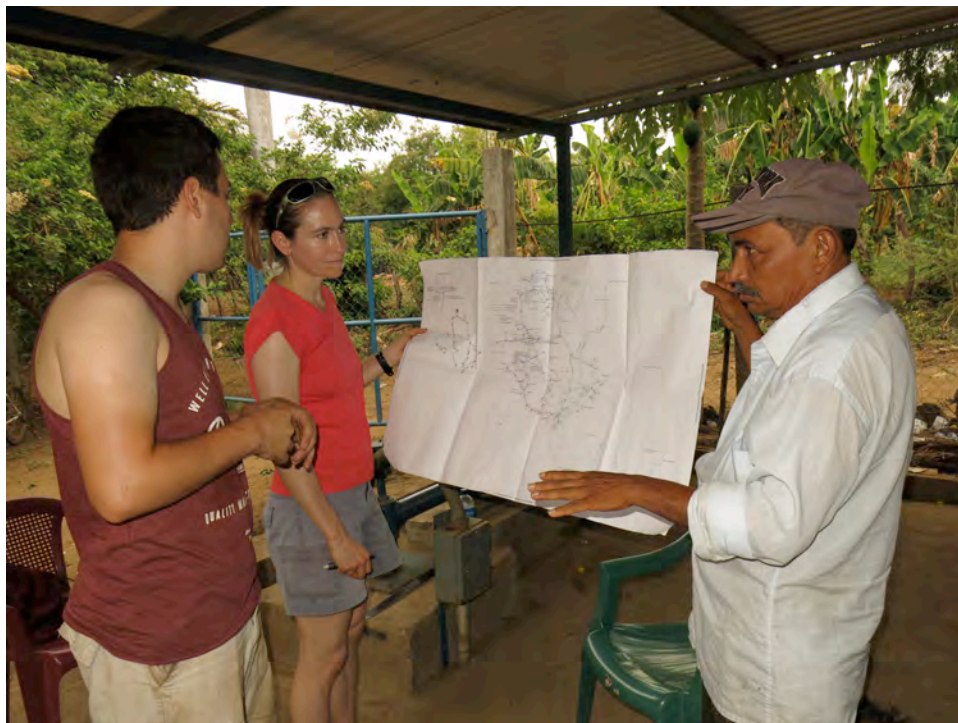
Updating the system map with the water system operators.

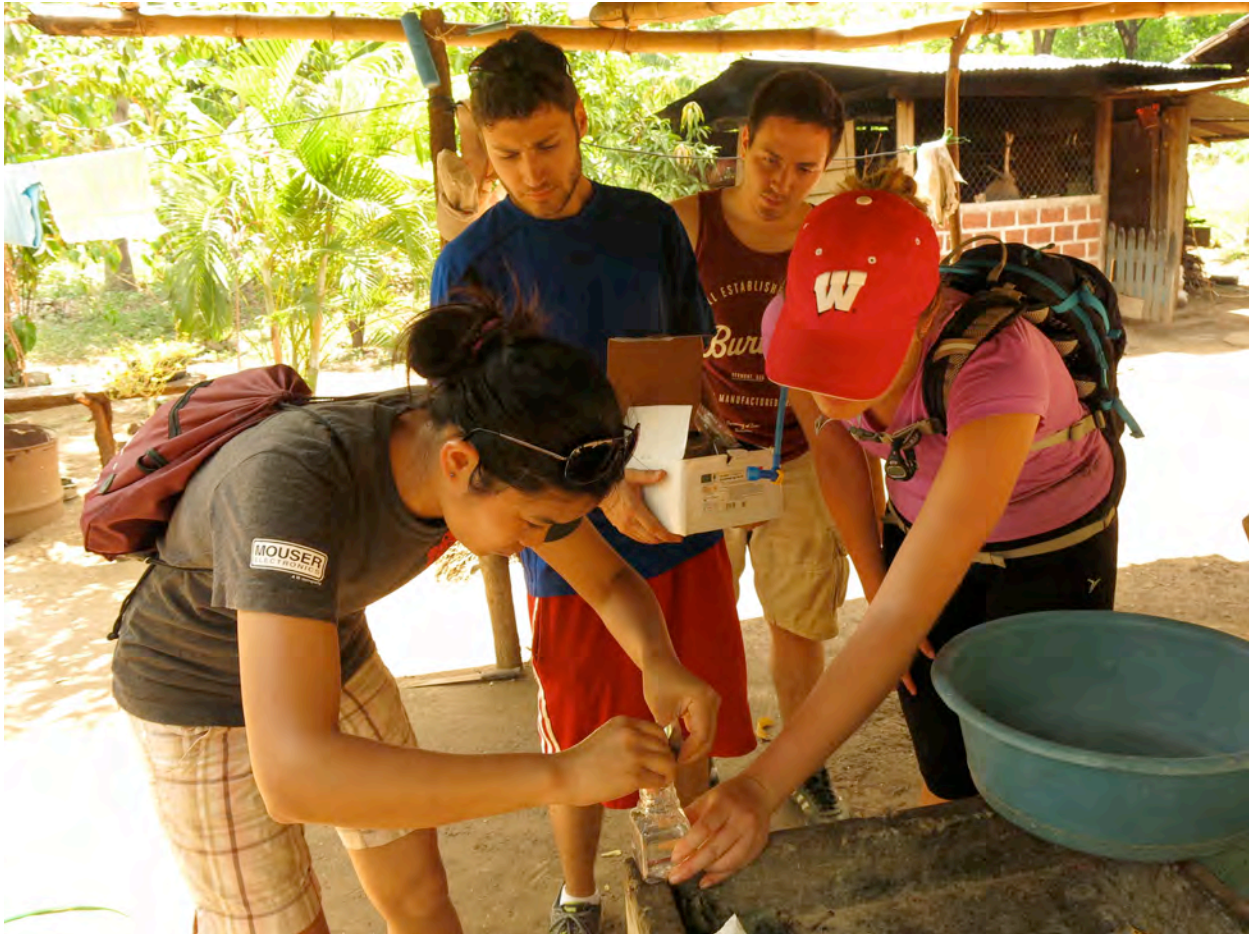
Performing bacteria testing on the system water.

We accompanied the health promoter and system operators on a technical evaluation of the system. We took bacteria samples, and all of them came back negative, indicating that the system is not contaminated and is being properly chlorinated.
